# Manhole Inspection Summary

Manhole # S45CC\_034MH

Insp Date: **6/30/08 12:51 PM**

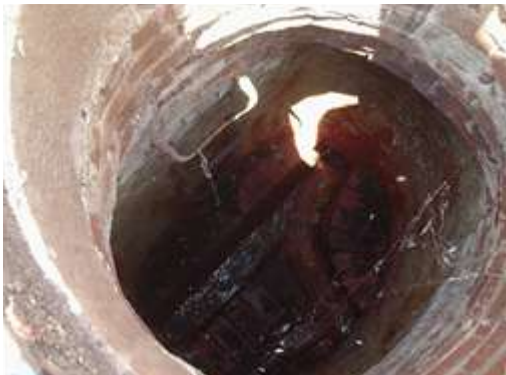
Defect 1

Count: **3** Missing: **0** ☒ **Corroded**

Corroded Steps

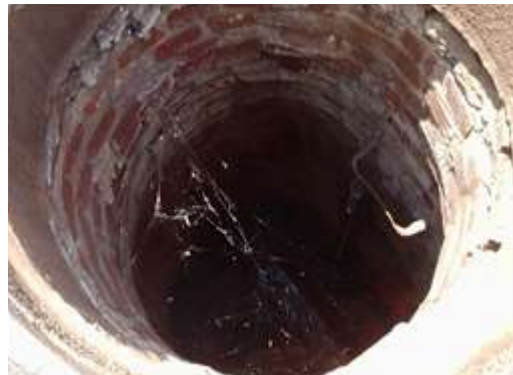
Defect 2

Condition: ☐ Sound ☐ Cracked ☐ Root Intrusion ☒ **Loose Brick** ☐ Deteriorated

Infiltration: ☐ None ☐ Joint ☐ Cracks ☒ **Mortar** ☐ Roots ☒ **Wall**

Missing Mortar

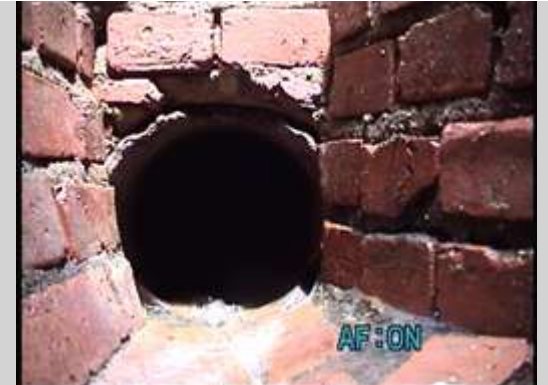
12 O'Clock Outflow

8 in. Circular Gravity Sewer  
Pipe Out @ 12 O'Clock

Pipe Height: **8.4** (in.) Rod and Bar (Angled)  
Pipe Material: **Clay** ☐ Pipe Lined  
Invert Depth: **9.90** (ft.) Flow Characteristics: **Slow**  
Deposits: ☒ None ☐ Mud ☐ Sludge ☐ Debris ☐ Grease  
Silt Depth: (in.) Deposits Extent:  
Infiltration: **None** Pipe Seal Cond: **Sound**

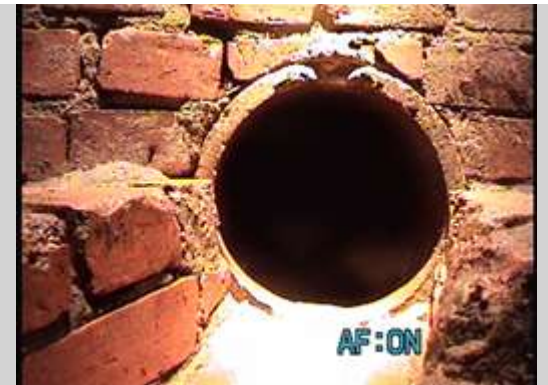
3 O'Clock Inflow

8 in. Circular Gravity Sewer  
Pipe In @ 3 O'Clock

Pipe Height: **8.4** (in.) Rod and Bar (Angled)  
Pipe Material: **Clay** ☐ Pipe Lined  
Invert Depth: **9.00** (ft.) Flow Characteristics: **Slow**  
Deposits: ☒ None ☐ Mud ☐ Sludge ☐ Debris ☐ Grease  
Silt Depth: (in.) Deposits Extent:  
Infiltration: **None** Pipe Seal Cond: **Sound**

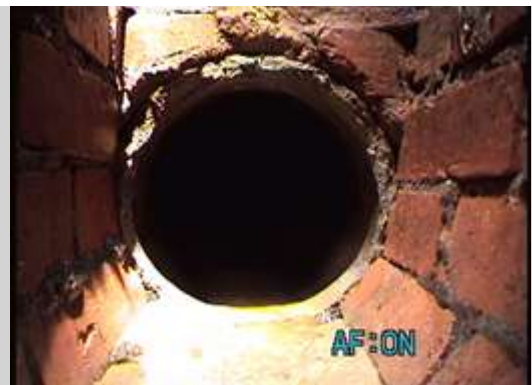
6 O'Clock Inflow

8 in. Circular Gravity Sewer  
Pipe In @ 6 O'Clock

Infiltration: **None** Pipe Seal Cond: **Sound**
